Inspection Report

Minerals Regulatory Program

Mine Name: North Lily--Tintic Project
Operator or Permittee Name:
North Lily Mining Company
Permittee Mailing Address:
1800 Glenarm Place #210, Denver, CO 80202

Permit number: M/023/007
Inspection Date: June 8, 2005

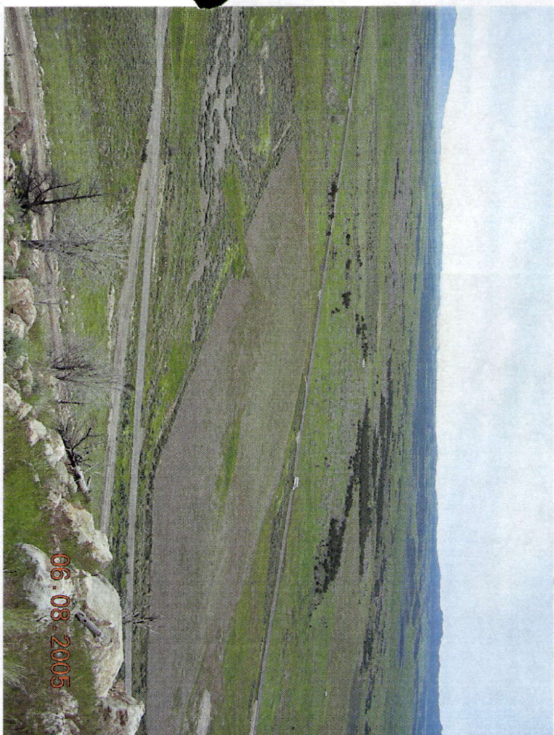
Photo 1 shows vegetation on the heap leach pile. The vegetation on this pile has progressed markedly (Photo 2) except on about the lower third of the slope (Photo 3). We wondered whether this portion of the area was not seeded but, other than the lack of vegetation, have no evidence this is the case. The dominant species is forage kochia, but there are some perennial grasses and other plants. We found some weeds on the pile, but not a lot. We also found thousands of forage kochia seedlings. My experience is that most of these will die, but some should survive and increase vegetation cover.

Photo 1. The heap leach pile. There is more vegetation than this photo would seem to indicate.

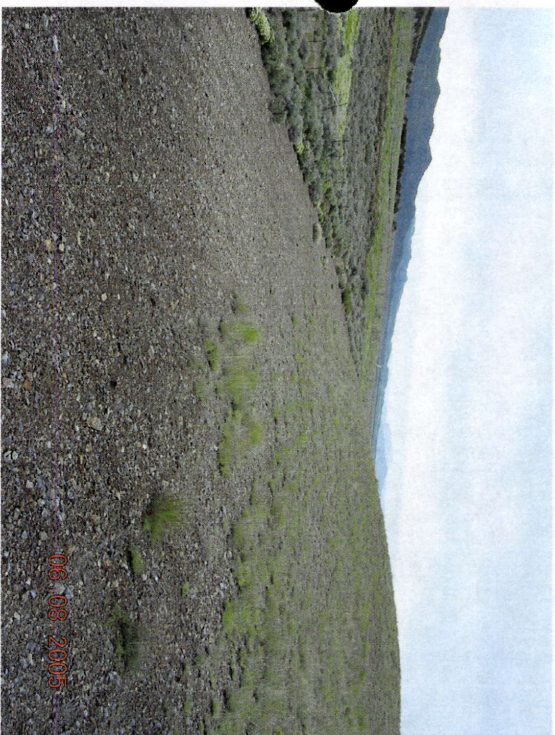
Photo 2. The lower third of the slopes has little vegetation.

I did not take vegetation cover measurements but do not believe either the heap leach pile or the facilities area meets release criteria. I suggest that the lower third of the heap leach pile slopes be roughened and reseeded. In addition, the operator should be working to control noxious weeds. Although this is difficult, especially considering that adjacent areas contain a lot of noxious weeds, the operator should be working actively to control them on the disturbed area.

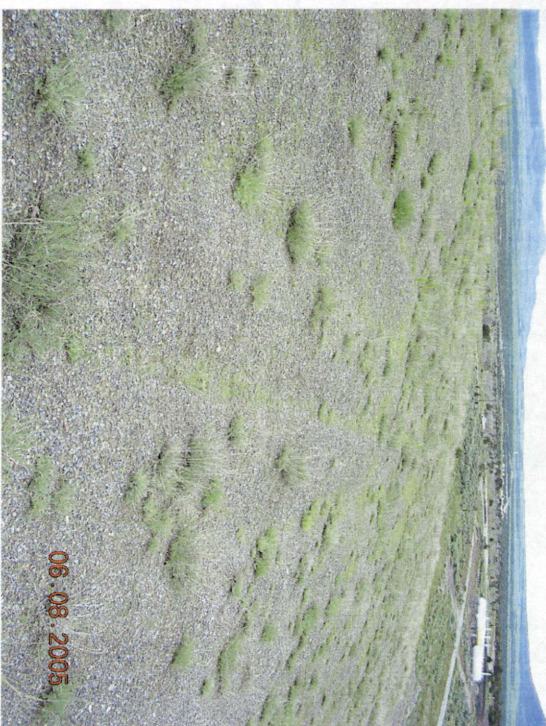
Photo 3. Vegetation on most of the pile has progressed a lot. Forage kochia is the dominant species. Note the number of seedlings, particularly in the depressions.

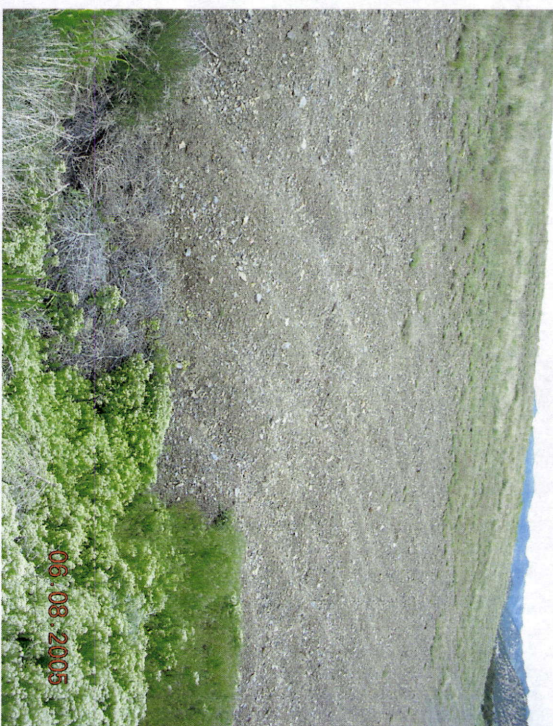
Whitetop, a noxious weed, is creeping into the east side of the area (Photo 4).

Photo 4. Whitetop coming in from the east.

If the operator feels the site meets the requirements for release, vegetation cover data supporting this conclusion should be submitted to the Division. However, even if there is adequate cover, I recommend that the bond not be released because of the noxious weeds. I recognize the difficulty in eradicating noxious weeds, but the operator should be actively working to eliminate them from the disturbed area. Noxious weeds are not conducive to any postmining land use.
